LPG

Explosion Damage

on The Buildings

Assoc. Prof. Dr. Paki TURĞUT
Harran University
Civil Engineering Department
Sanliurfa, TURKEY
Email: pakiturgut@harran.edu.tr
<http://eng.harran.edu.tr/~pturgut/>

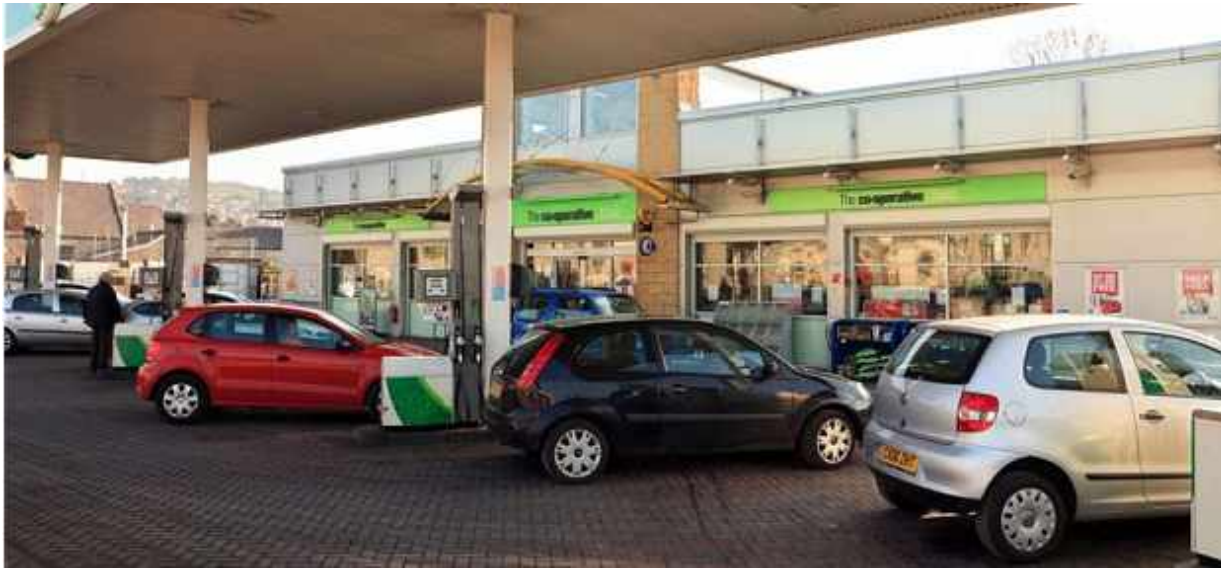
In 17 June 2011, at Karakopru town of Sanliurfa in Turkey, a LPG explosion at a petrol station took place and as a result of this explosion 1 person was died and 21 people were seriously wounded.

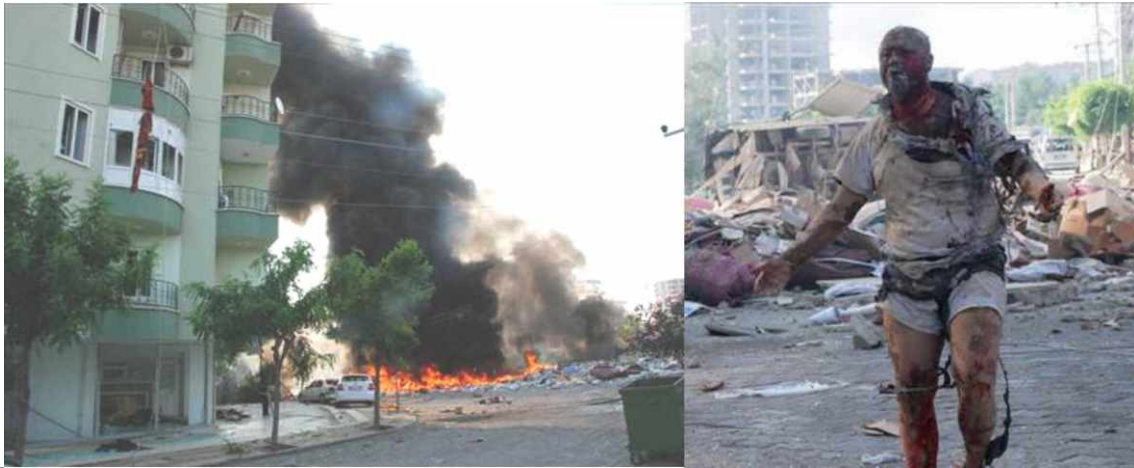
At the location of incident about 200 homes and shops were damaged at various levels, and 20 vehicles were completely destroyed.

All textile materials were burned in the basement of petrol station.

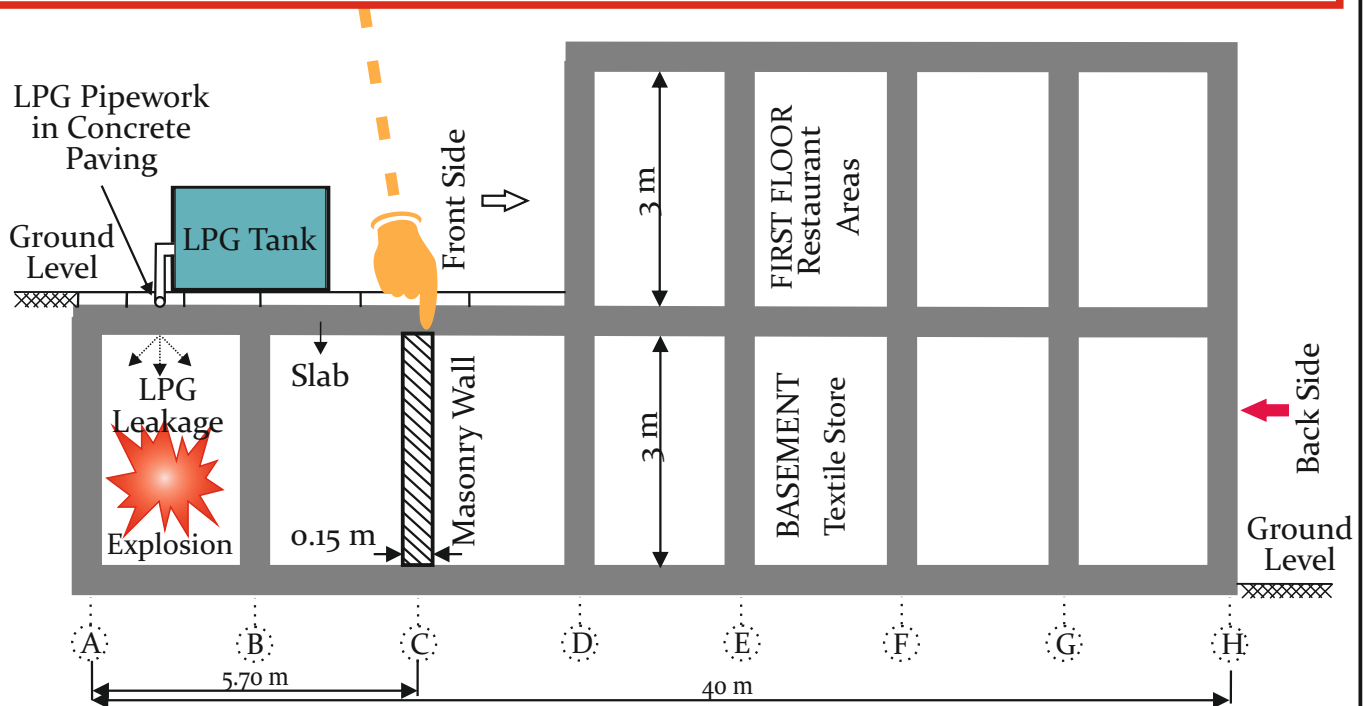
The basement had a masonry partition wall but not it in original project of building. It was reported that the door in partition wall had been closed. Thus, the higher concentration of LPG was accumulated in this confined space.

The partition walls should be lightweight and designed to open quickly in case of explosion.

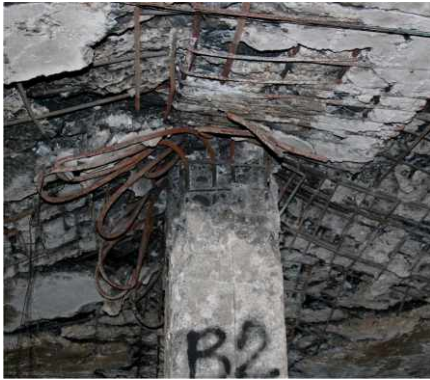
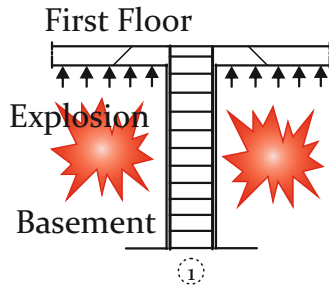
B2 column damage mechanism (heavy damage)

The slip length of longitudinal bars at the column top was about 100 cm. This showed explicitly that the ceiling in this point was lifted higher than 100 cm.

Unseating of beam-slab system from the column head and slipping of lap bars

Falling of slab and buckling of lap bars

Completely buckled bars

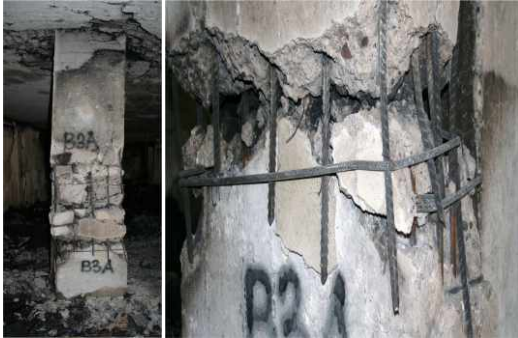
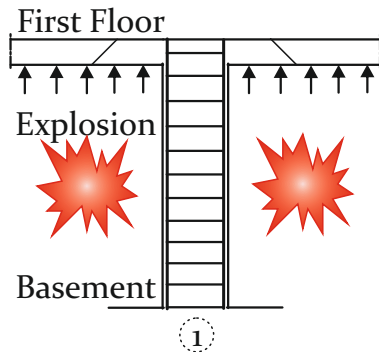
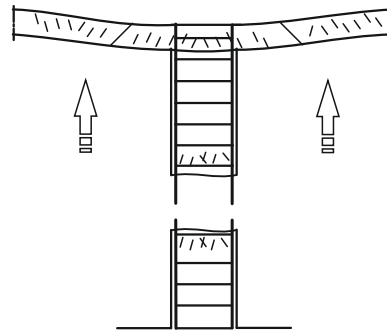
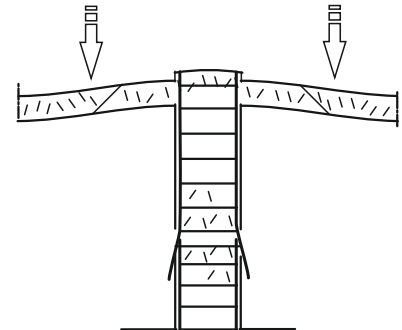
B3 column damage mechanism (heavy damage)

All the longitudinal bars in the column B3 were completely fractured, due to the consequence of the upward movement of the RC beam-slab system with the effect of strong explosion.

②
Fracture of column under the big axial tension caused by explosive pressure

③
Falling of slab and fractured up part of the column

The force applied on the column B₃
due to blast pressure
is
about 178 TON!

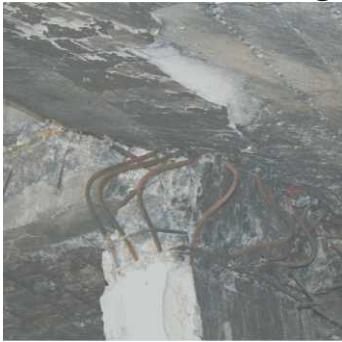
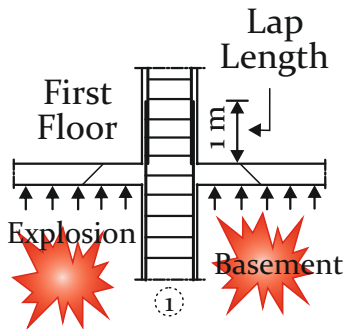
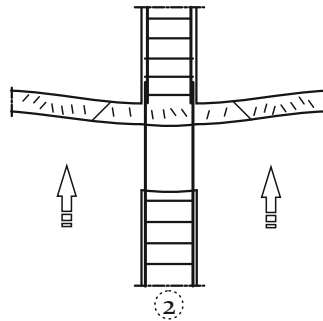
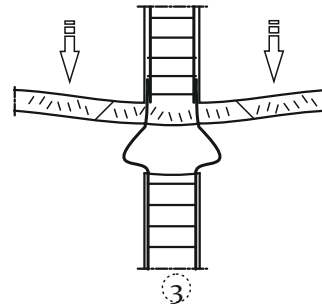
D2 column damage mechanism (heavy damage)

The longitudinal bars in the column D2 slipped along the lap length, while beam-slab system had lifted above. Excessive buckling in lap bars took place under the effect of falling down of the beam-slab system with the decay of explosive pressure.

Partial slipping of lap bars with the effect of explosive pressure

Buckling of lap bars with the effect of falling down slab

Completely buckled state of lap bars at the column head

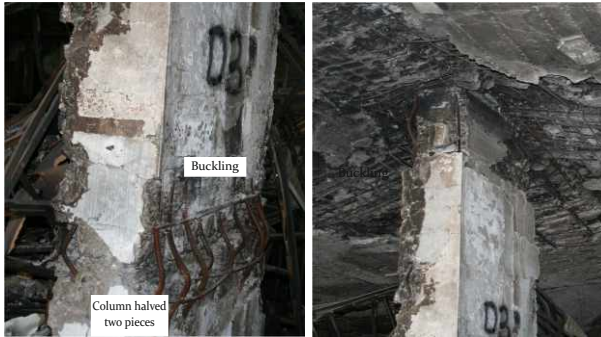
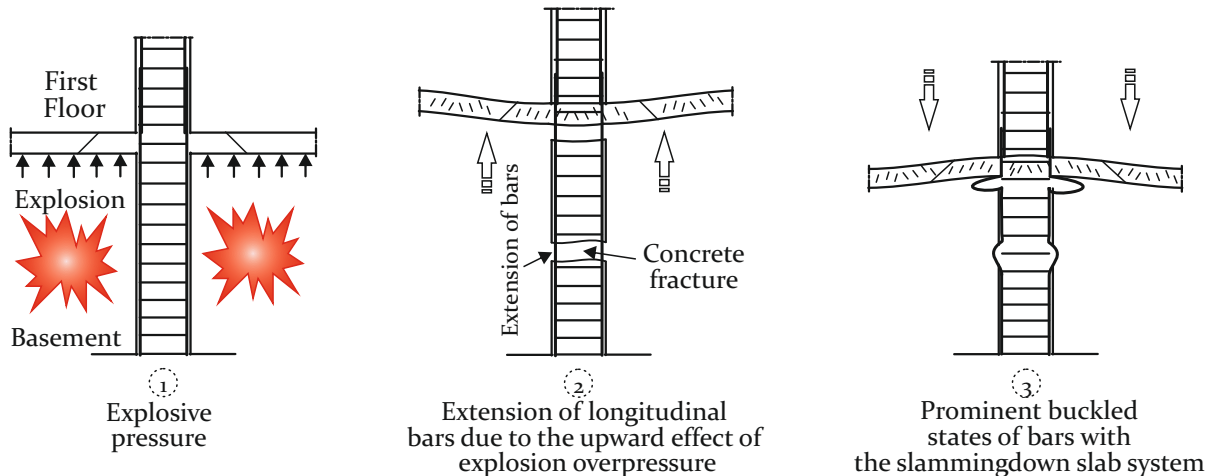
D3 column damage mechanism (heavy damage)

Column D3 was divided into two parts by fracture of concrete and, firstly elongation and then buckling of longitudinal bars at nearly mid-point of the column. In the column, besides mid-height, at the column top, buckling of longitudinal bars were observed.

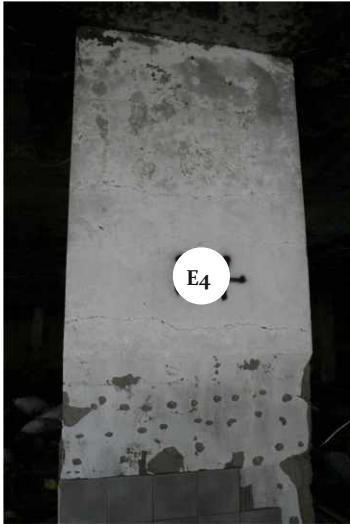
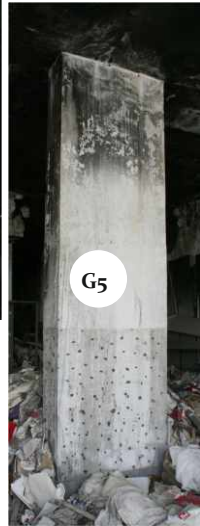
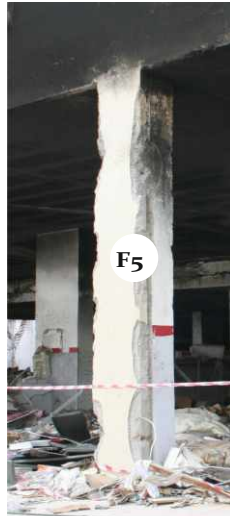
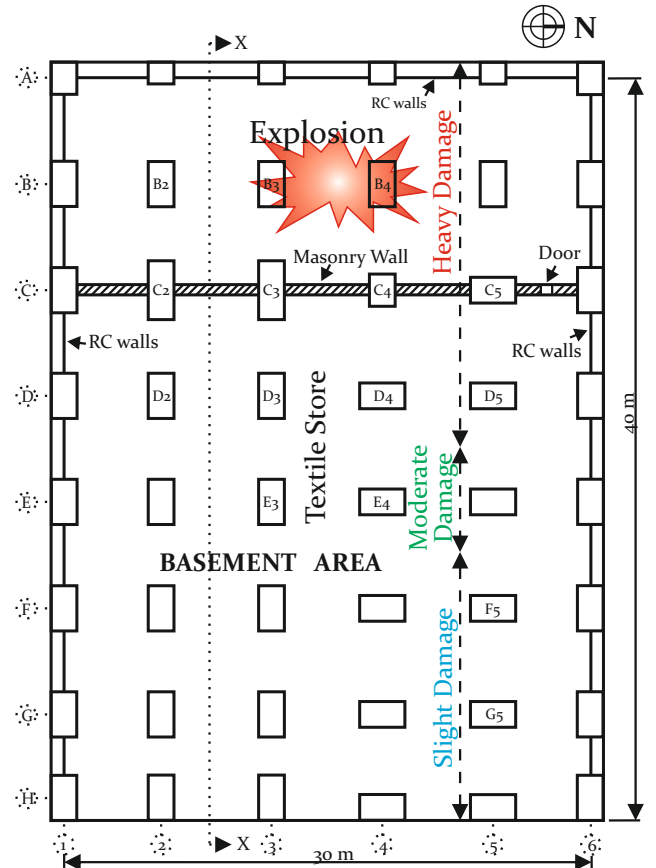
Slightly damaged columns far from the explosion starting point!

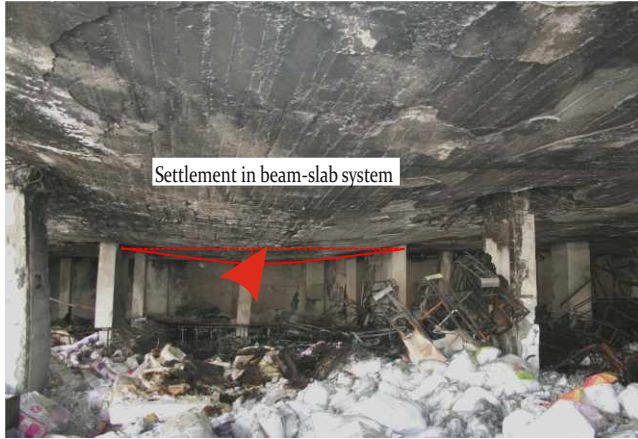
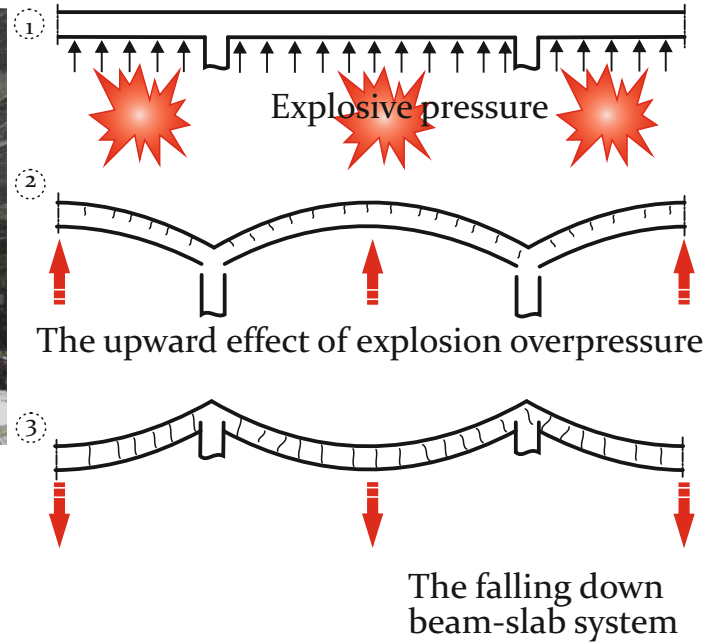
Damage in beam-slab system (heavy damage)

Like a carpet!

This building was only designed for dead and live load, not for explosive pressures.

This upward load requires that the beam-slab system would be reinforced to resist loads opposing the effects of gravity.

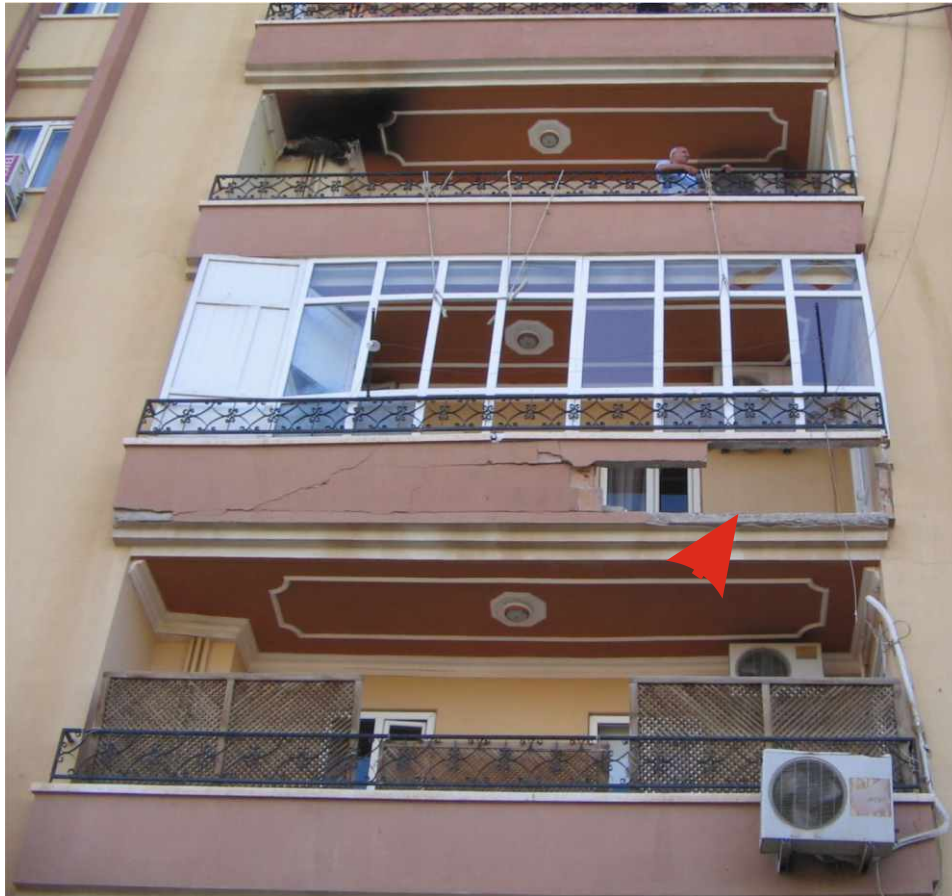
An interesting
damage in an apartment
nearby the gas station!
