LPG

Explosion Damage

on The Buildings

Assoc. Prof. Dr. Paki TURĞUT
Harran University
Civil Engineering Department
Sanliurfa, TURKEY
Email: pakiturgut@harran.edu.tr
<http://eng.harran.edu.tr/~pturgut/>

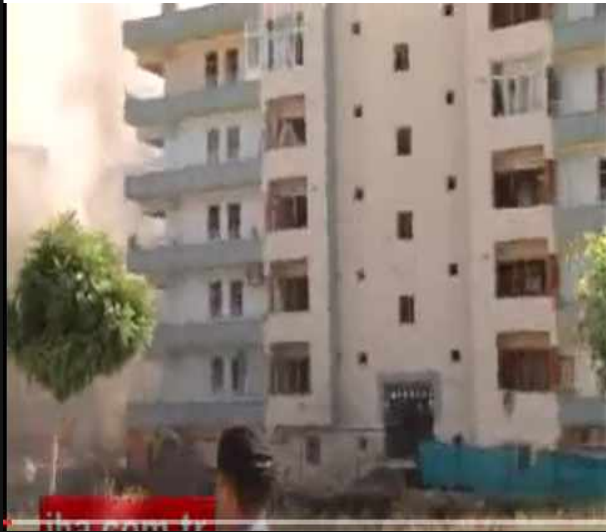
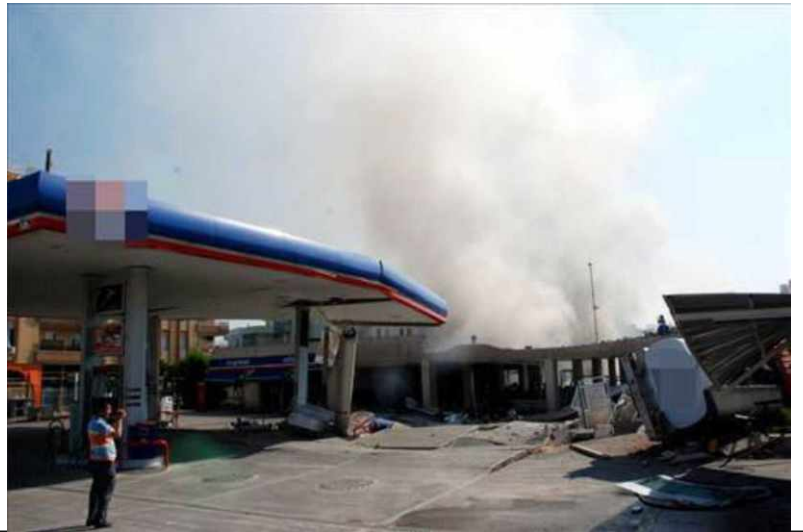
The building mentioned had also a family restaurant. Luckily, the event was not occurred at midday or evening.

There would be a great tragedy if the incident had taken place at these times of the day.

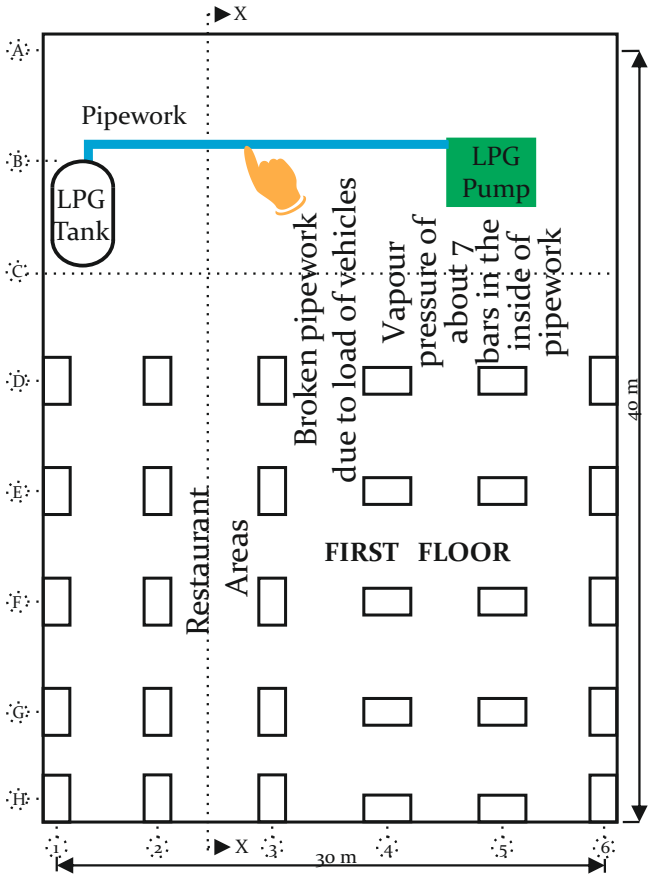
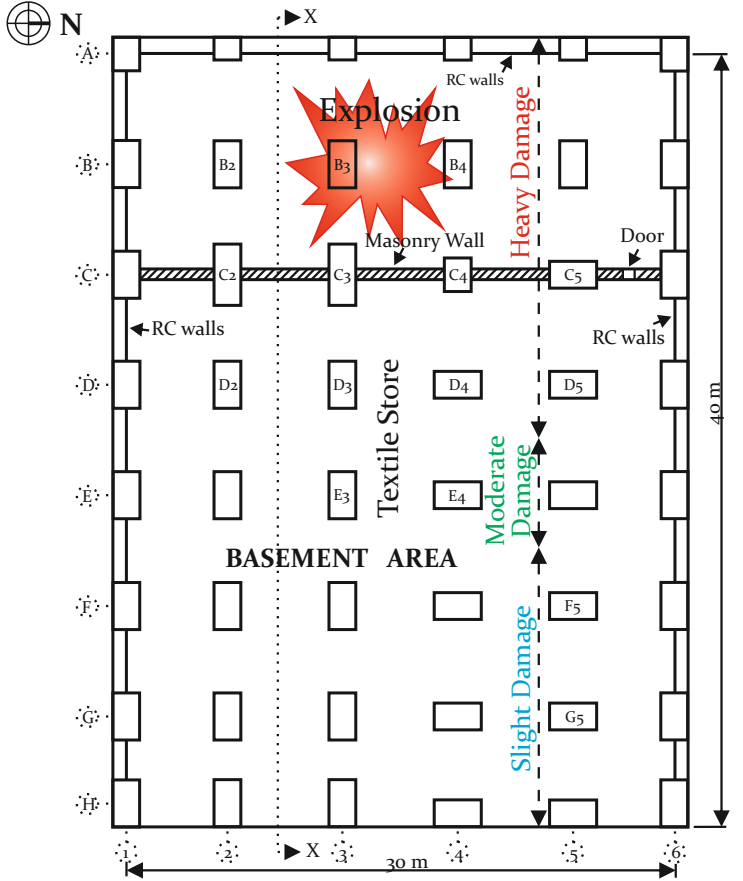
The detailed inspection revealed that the explosion was caused by the ignition of an explosive air that had formed at the basement space of the building due to the leakage of LPG.

Several neighborhood residents expressed that they had smelled the LPG stenching agent before the explosion.

The explanation is that, because the LPG was heavier than air, the smell would probably have been only at the basement.

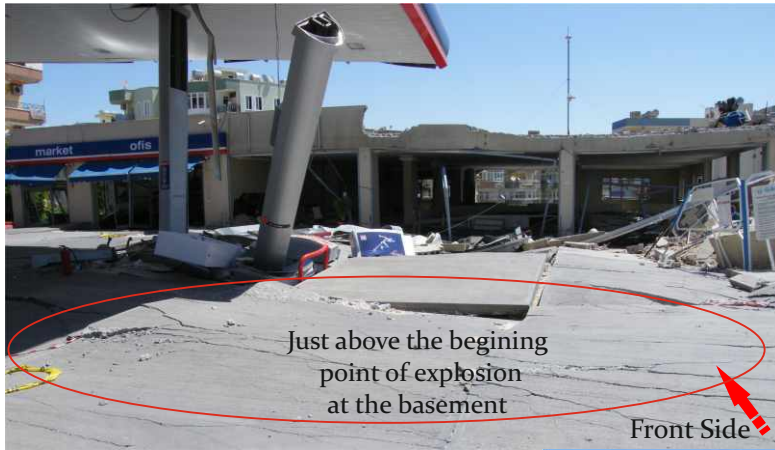
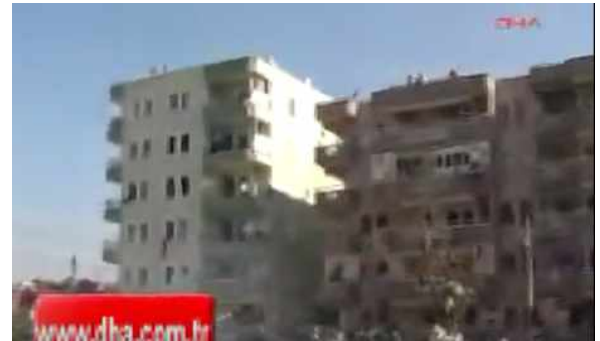
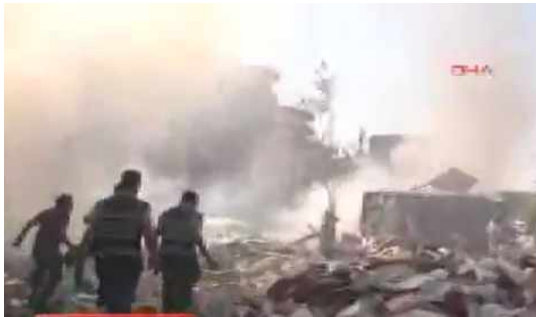
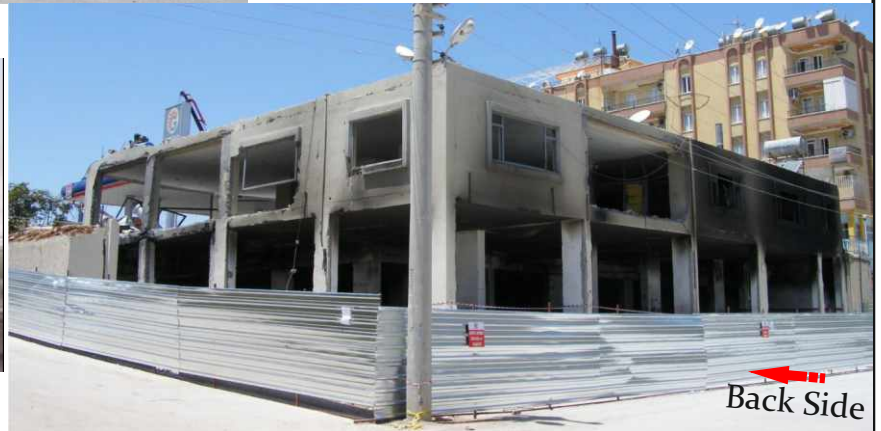
The direct cause of the explosion was the escape of LPG from the fractured underground pipe in the concrete paving on the basement slab under the effect of continual loads of vehicles.

The failure of the pipe caused a significant leak of LPG into the basement.

Then, the accumulation of this LPG in there constituted an explosive mixture of air.

The basement space had no mechanical ventilation.

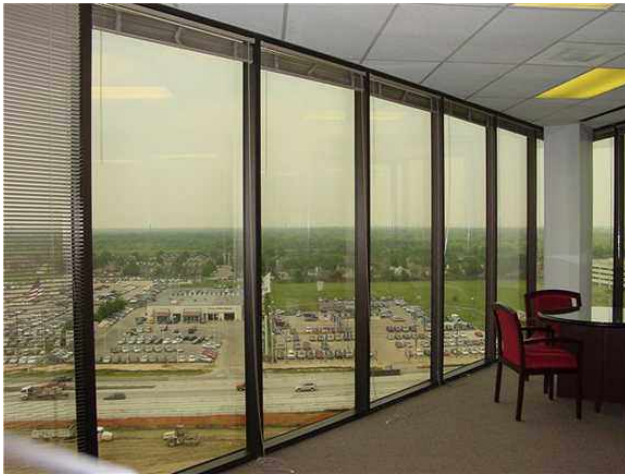
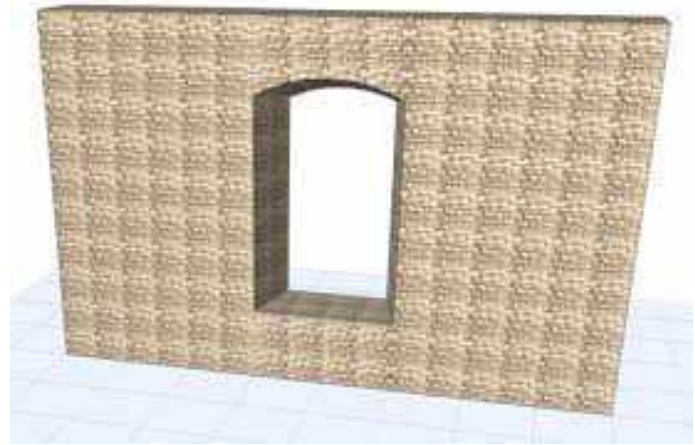
An open wall (wall with windows) is normally the best solution from an explosion point of view.

If a large part of the wall is open, the natural ventilation is good and explosive cloud formation is less likely.
